NSWCCD-65-TR-2003/39 September 2003

SIDER Testing of Two Range Safety Craft

SUBJ: STRUCTURAL IRREGULARITY AND DAMAGE EVALUATION ROUTINE
(SIDER) INSPECTION OF SHIP STRUCTURES

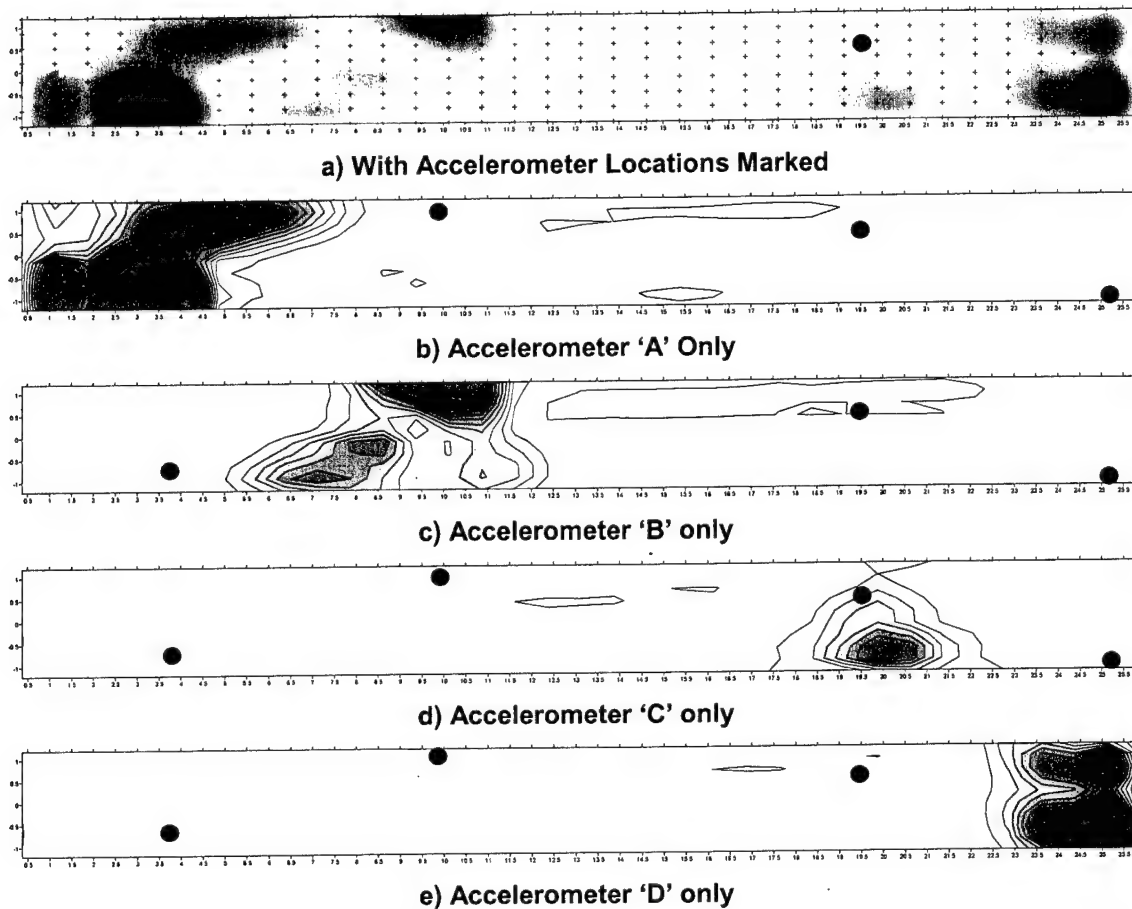
Figure 7. Test ID R2 SIDER Results

It is a documented aspect of the SIDER algorithm that the procedure may produce features at the locations of the accelerometers. This is a theoretical aspect, but the effect has only been observed once before, while testing a 100% rubber submarine component. The component did not comply with one structural requirement for SIDER – that the structure be resonant. Figure 7 a) shows the SIDER results for Test ID R2 with the approximate positions of the accelerometers marked with black dots. There is some concern that at least three of the features are coincident with the accelerometers. Figure 7 b) through Figure 7 e) enhance this concern by showing the SIDER results obtained by using just one accelerometer at a time. It should be noted that this single accelerometer analysis is *not* part of the documented SIDER procedure, and is used here for demonstrative and analytical purposes only.

The SIDER theory suggests that these 'accelerometer features' are only effective for about two grid points from the accelerometer location, and beyond that the results are unaffected. Therefore, it was decided to implement a blanking algorithm to see if the small hammer would provide results similar to those from the larger sledgehammer. The blanking algorithm uses data from all four accelerometers for most of the structure. However, when the analysis is near an accelerometer, the results from the nearby accelerometer are 'blanked' and the results only obtained from the other three remote accelerometers. Figure 8 shows the effect of using the algorithm for this structure. By comparing Figure 7 a) with Figure 8, it is readily seen that this accelerometer problem is solved.
